FLUID APPLIED RESTORATION COATING SYSTEM

TYPICAL GUTTER DETAIL

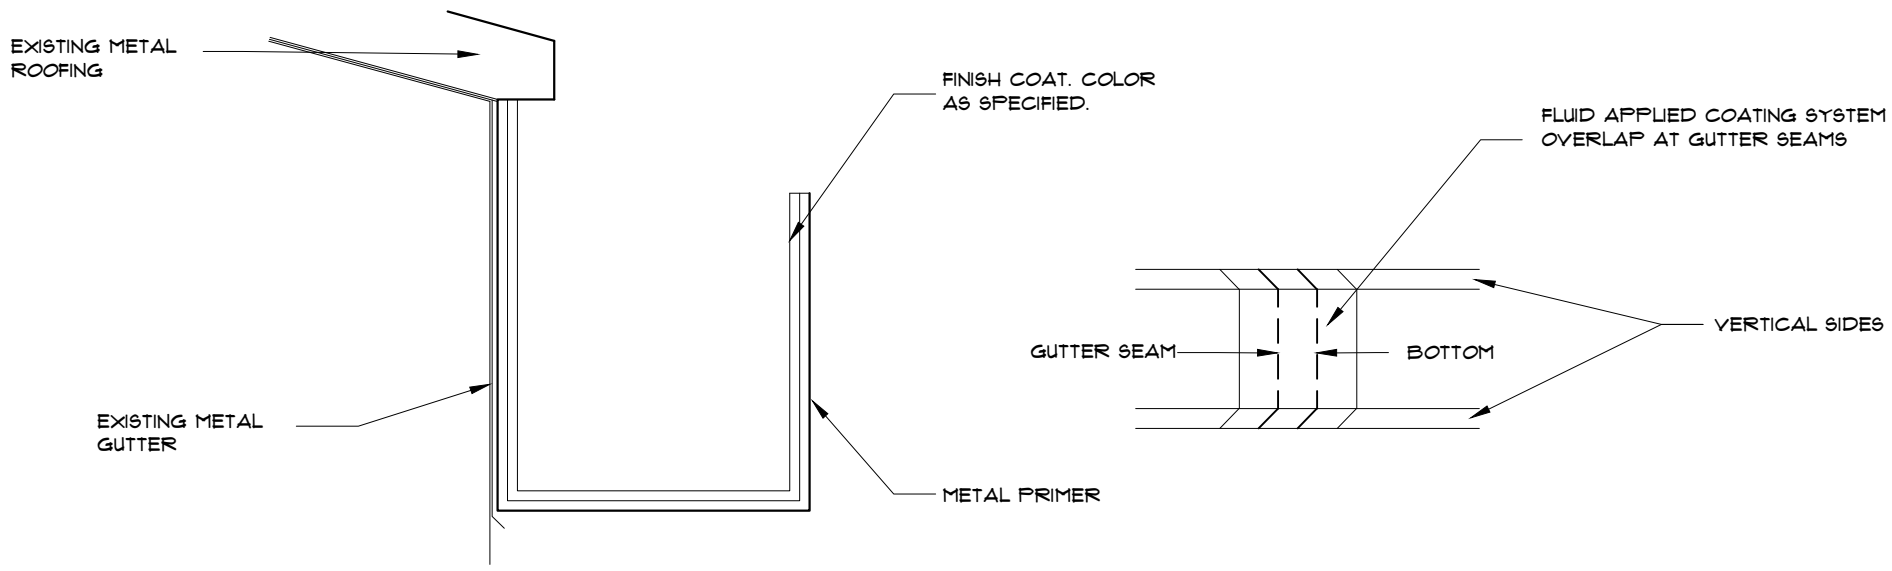
SECTION

GUTTER PLAN

1. PREPARE ALL GUTTER SURFACES AS REQUIRED BY FLUID APPLIED SYSTEM MANUFACTURER.
2. PRIME ENTIRE GUTTER WITH #960 METAL PRIMER @ 200 SF/GAL MINIMUM COVERAGE.
3. REMOVE LOOSE OR DAMAGED FASTENERS AND REPLACE WITH FASTENERS DESIGNED TO PENETRATE THE DECK AND SUPPORTING MEMBERS WITH NEOPRENE WASHERS AT THE SCREW HEAD.
4. GUTTER CONFIGURATIONS MAY DIFFER FROM THE PROFILE INDICATED, BUT THE APPLICATION SHALL REMAIN SIMILAR.
5. FLUID APPLIED RESTORATION COATING SYSTEM - BASE COAT, REINFORCED FABRIC, BASE COAT 2, AND FINISH COAT COMPONENTS. ALL GUTTER SEAMS ARE TREATED WITH BASE COAT AND 4" OR 6" FABRIC DEPENDING ON GUTTER PROFILE. ALL FASTENERS ARE TREATED WITH #950/951 (ACRYLIC) OR #9100 (SILICONE).
